# Julia Tuttle Basin Seagrass June 2017 Update Miami-Dade RER-DERM

# **Seagrass loss event in North Biscayne Bay**

## **Julia Tuttle Basin**

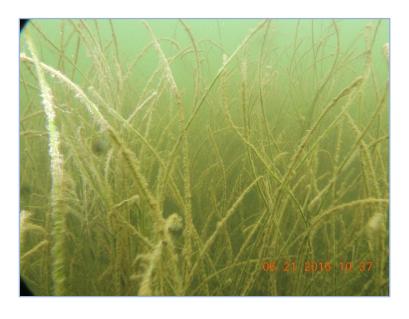
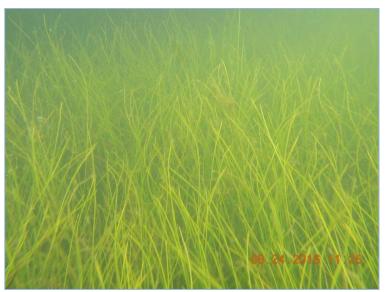
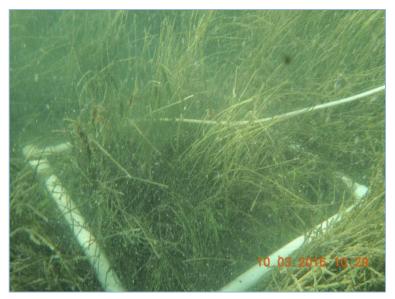
## **Julia Tuttle Basin Seagrass**

- The basin seagrass community was predominantly characterized by high biomass high density Syringodium.
- Photos taken during 2016 surveys near fixed transect which appeared stable.

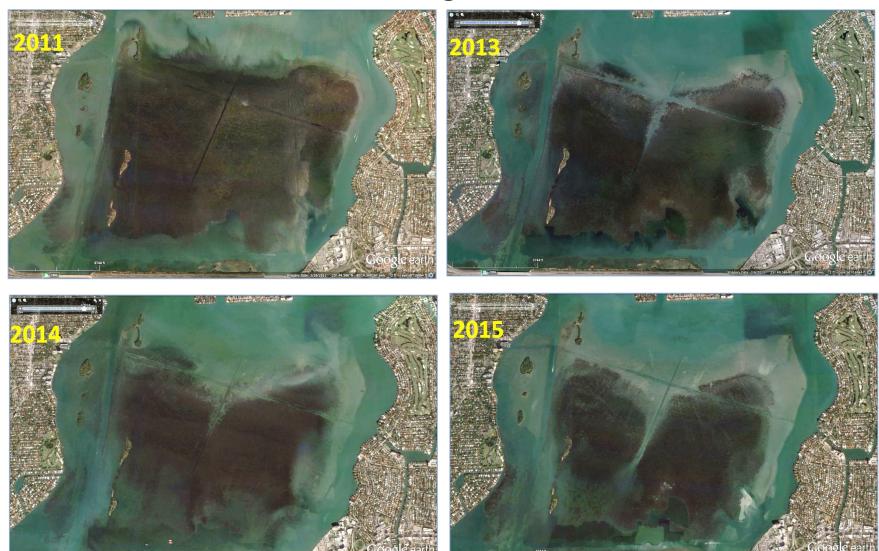
# **Julia Tuttle Basin Time Series images**

- Losses appear evident in 2013 Google Earth images.
- North to South and progressing along remnant channels.

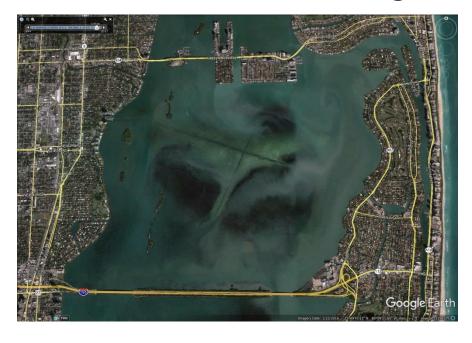
• 2016 Google Earth Imagery.

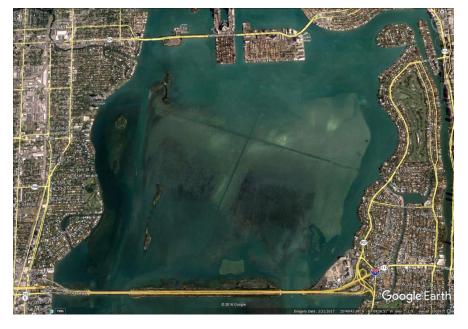
2017 Google Earth Imagery.

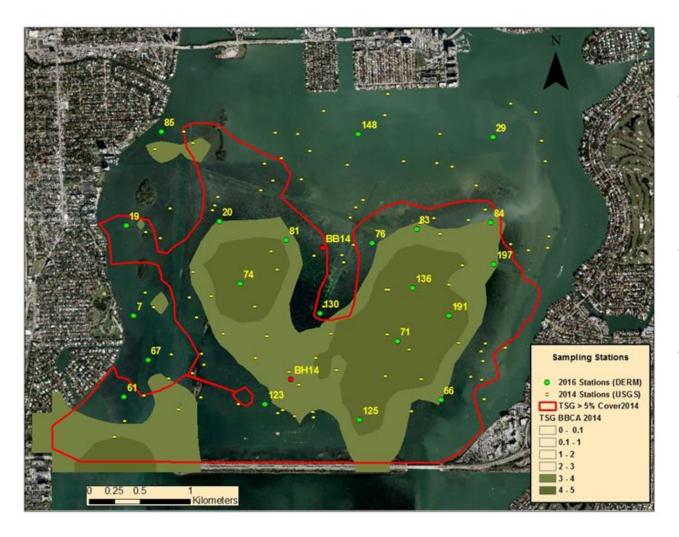
## **2014 Estimates of Seagrass Losses**

- Contour projections of available USGS data showed the extent of the seagrass bed in 2014.
- A subset was resurveyed by DERM in 2016.
- Monitoring using these data is continuing.

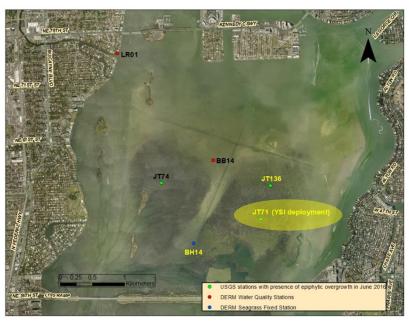
## **2016 Continuous Dissolved Oxygen Measurements**

- Deployed instrument in area with observed cyanobacteria-epiphytic overgrowth. Although dissipated compared to earlier observations.
- Dates 9/26/16-10/08/16.
- No measurements <2.0mg/l.</li>

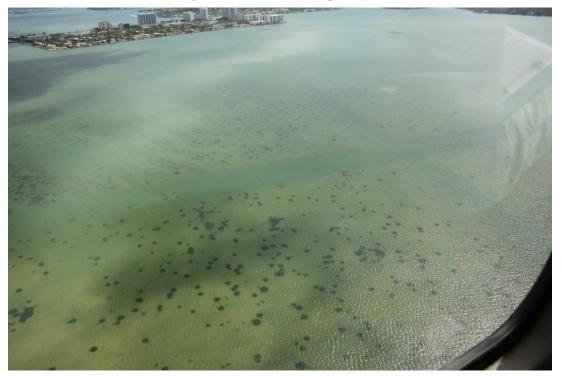
## **Latest Observations and Study Plans Going Forward**

- Recent observations indicate the seagrass losses have progressed since 2016 and patches of *Halimeda* are now present.
- Increased spatial sampling planned for this basin and others in the North Bay.
- Frozen *Synrigodium* samples for nutrient content analysis and basin wide monitoring planned for 2017.
- Review existing light penetration data from pre vs. post seagrass loss events and to better quantify the light requirements needed for seagrass recovery.
